## **The Sanborn Covered Bridge**

**Lyndonville, Vermont**

**A Preservation Trust of Vermont**

### **Technical Assistance Survey**

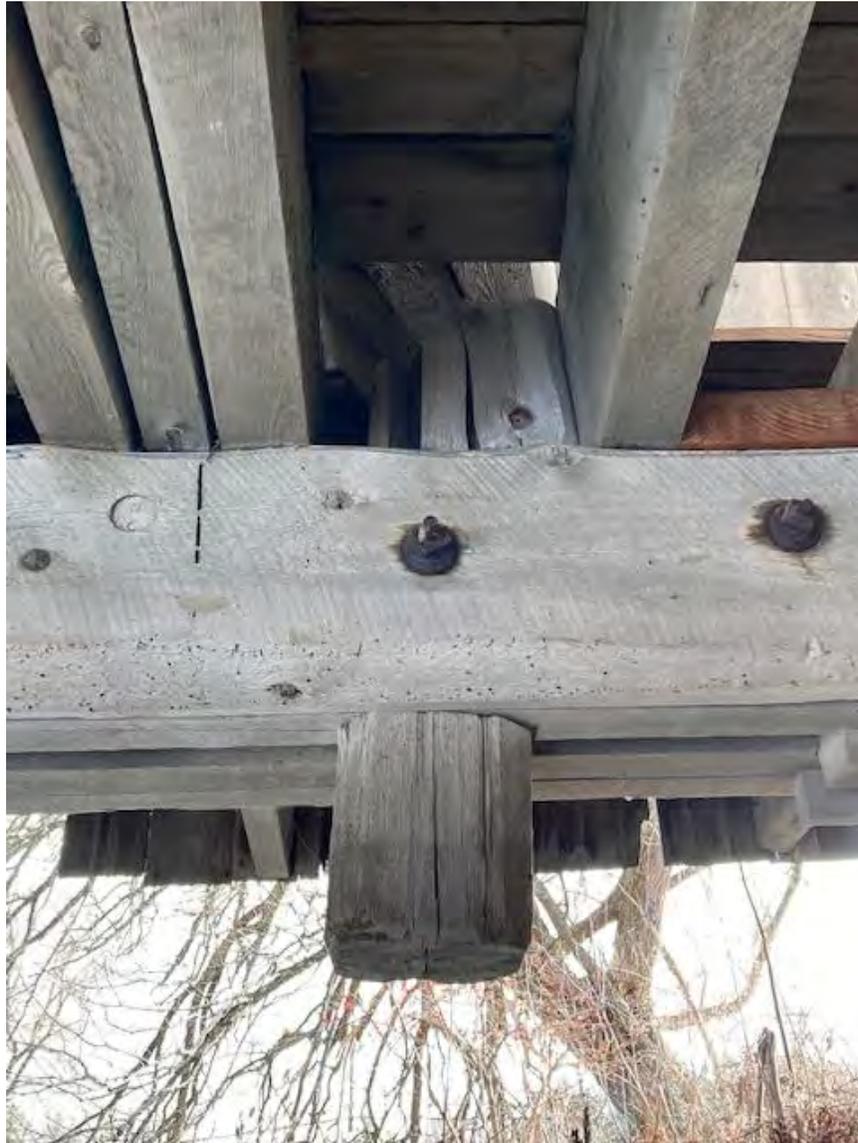
Where the bridge hits the abutments it is supported on 12 x 12 cantilevered bed timbers between the bottom chords and a concrete beam. The bed timbers are both sacrificial, i.e. to themselves rot rather than the bottom chord, and to spread the load and slightly reduce the span.

The abutments are rather good and very old fieldstone masonry with a less good concrete beam poured on top, suffering from ground and drainage problems.

A further problem is the bad location of the current bearing of the bottom chords on the abutments, putting maximum loads in the midspan of the panels rather than right behind a column position.

**Sanborn Bridge: Abutment concrete forms, crushing bed timber and bottom chord**

**2. Abutments and Bed Timbers:** The stone and more so the concrete abutments are in poor condition and need to be reconfigured to get the bridge higher above the river. If the Bridge were lifted 2 or 3 feet higher a number of purposes would be served.

Secondly it would make possible the cantilevering of a bed timber, or concrete cantilever, approximately 2 ft. deep that would cause the trusses to spring from immediately behind the first major column, and thus avoid bending and damaging the bottom chord.

The abutments to the restored Sanborn should be new due to the poor condition of those existing. They can be made of concrete, fieldstone or large granite blocks. Even though stone foundations and bridge abutments have successfully performed for 1000's of years, far outperforming concrete, you will be fortunate to find any modern engineer willing to specify such a beautiful construction.

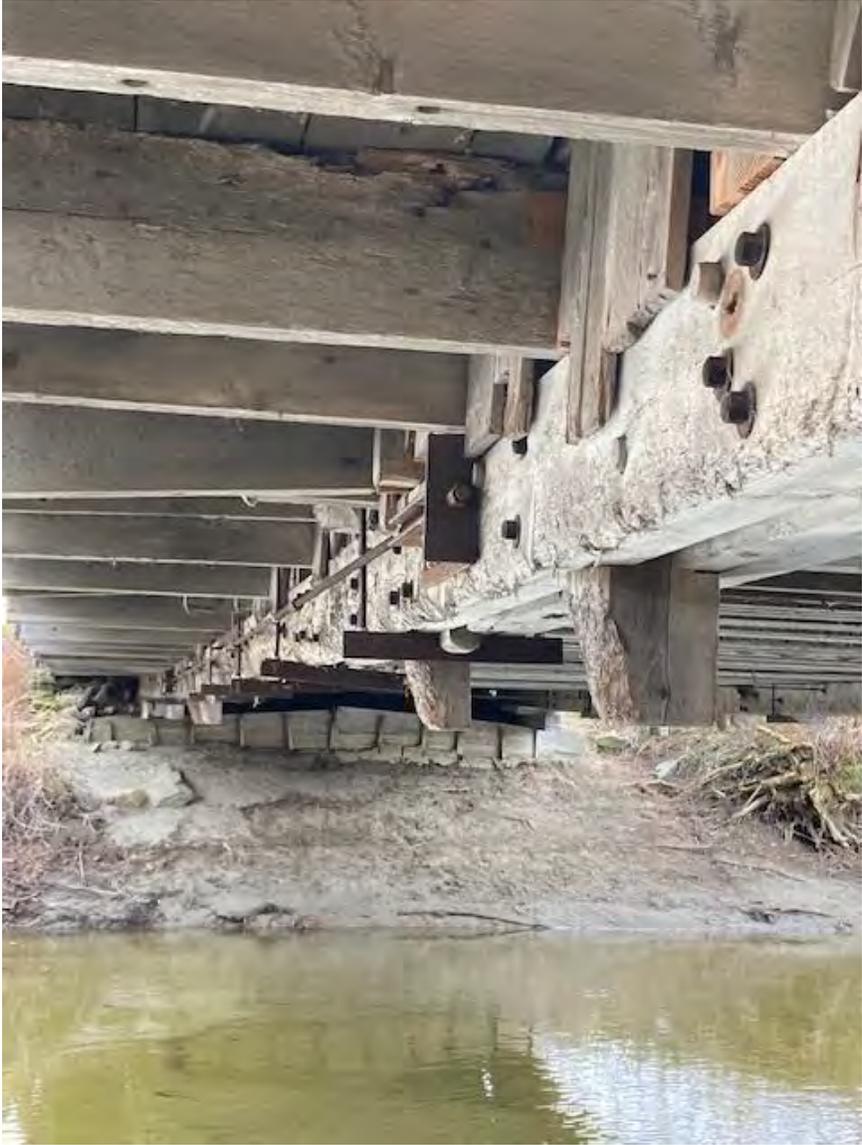
First: The majority of the column bottoms, as well as the counterbrace extensions, both of which carry the bottom chord in tension, have been either broken off entirely or damaged by ice and debris. These same environmental effects have ground away at the upstream bottom chord and changed its shape and reduced its section. At most locations pairs of 5/8 in. steel rods, dropping from the top chord parallel to columns, are adding crucial assistance to the damaged posts in carrying the bottom chord.

**Sanborn Bridge: broken and displaced post bottom near abutment**

Following these or some other method of removal and dismantling, the trusses can be rebuilt using even larger posts at the first three positions out from each abutment. The current posts, reaching a maximum size of 9 ½ x 9 inches at the first post past the abutment might be changed to 12 x 9 inches and made of a stronger species such as hardwood or Southern Yellow Pine or Douglas Fir. In addition, the bottom chords, at least for their first thirds beyond the abutment can be increased in size to 16 inch deep material in as long lengths as possible. This deeper chord is accommodated by the fact that most of the columns and counterbraces are being changed anyway. A effective scheme of shear blocking, pinning, bolting and dapping the lamina at the columns can be devised.

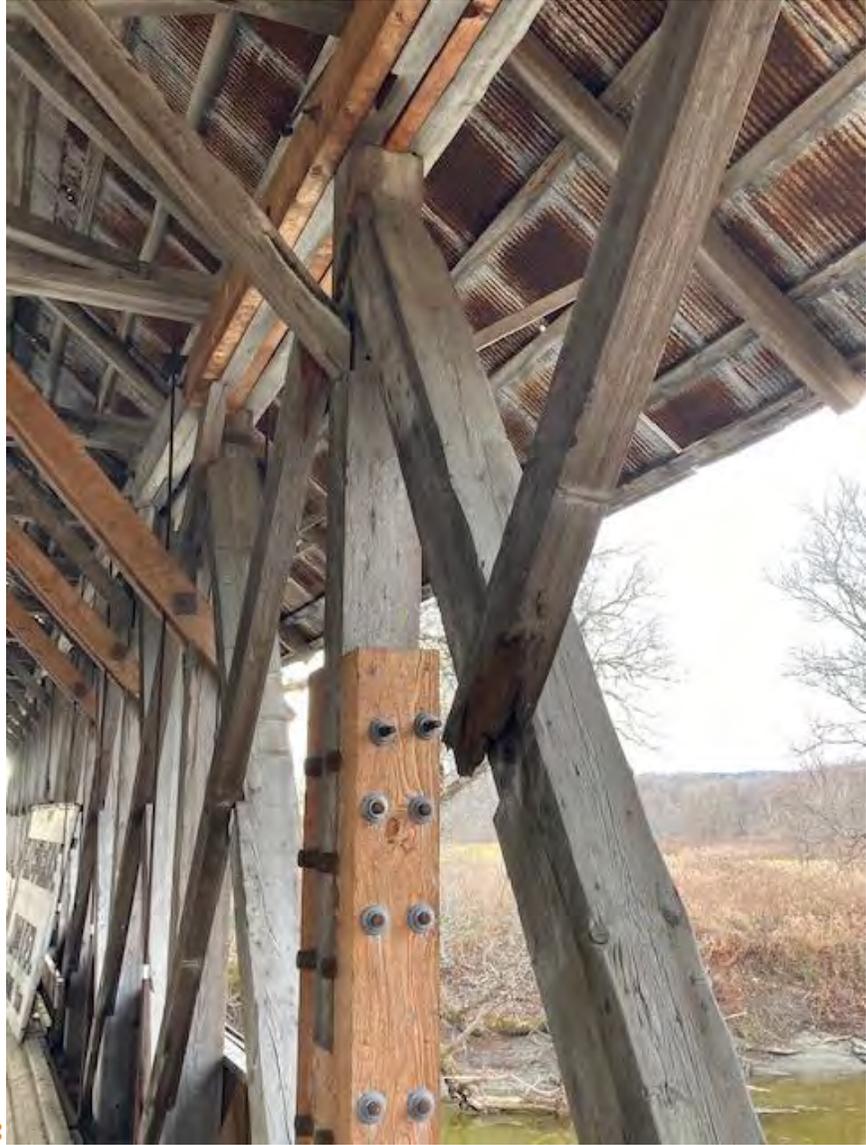
**Sanborn Bridge:  
post bottoms**
